# THINK GLOBALLY; ACT LOCALLY

## SUPPLEMENTARY CHECKLIST FOR SAFEGUARDING HISTORIC OBJECTS AND INTERIORS FROM EXTREME HAZARDS

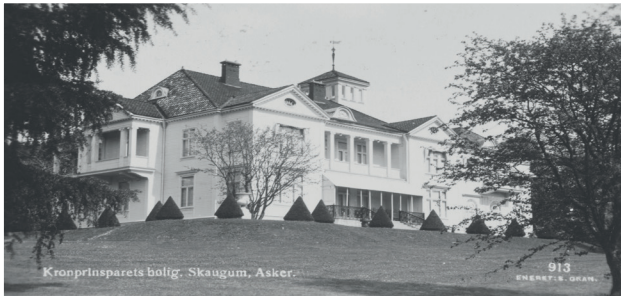
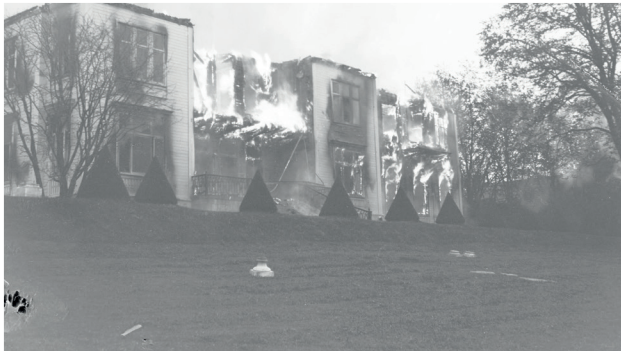
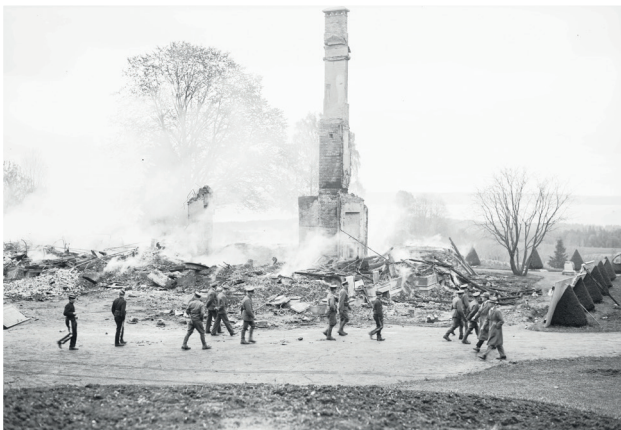
Figures 1, 2 and 3 (to the right). Fires and floods top the list of disasters affecting cultural institutions. Skaugum in Asker Municipality is a manor house and the residence of the Crown Prince of Norway, which caught fire in 1930. Photographs before, during and after the fire. Figure 1: S. Gran 1925. Figures 2 and 3: Steen and Henriksen 1930. (All photographs: Nasjonalbiblioteket [www.nb.no](http://www.nb.no), CC0 1.0 licence).

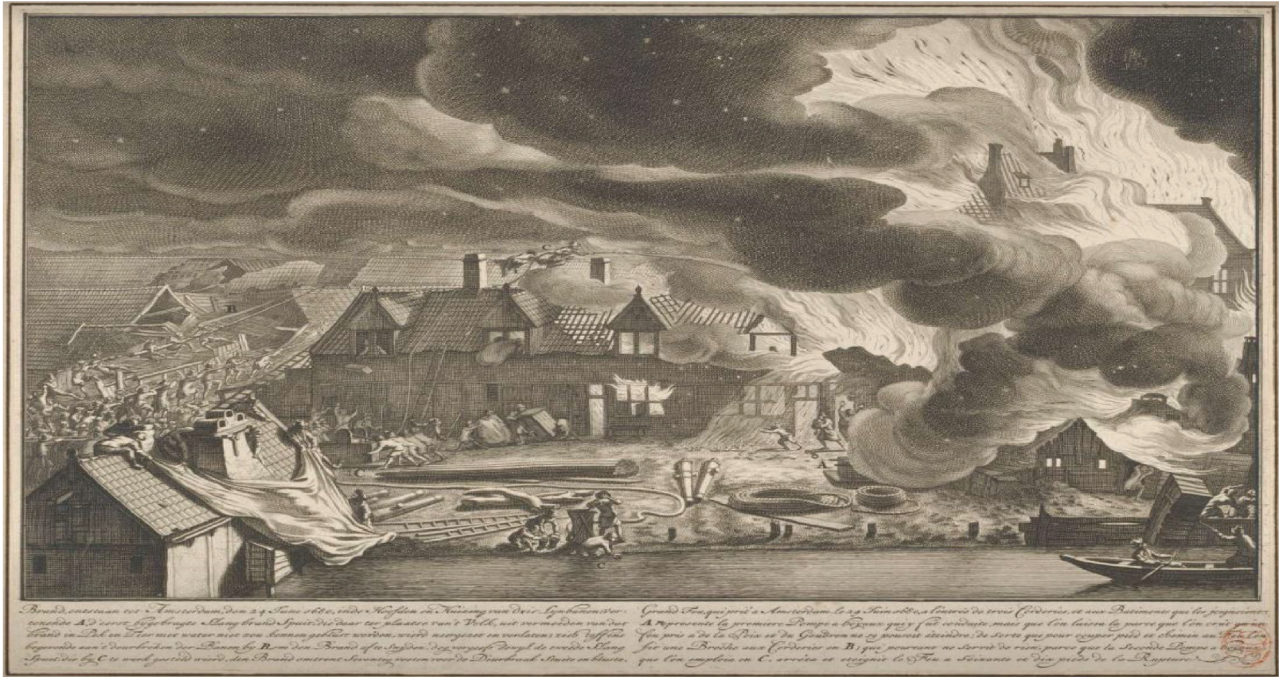
Figure 4. “Brand in de lijnbanen op de schans aan de Smallepadsgracht, 1680”, showing the use of fire-protective textiles for mitigating the fire damage to whole buildings in the Netherlands. Etching/engraving by Jan van der Heyden 1690–1735. Collection by Rijksmuseum (CC0 1.0 licence).

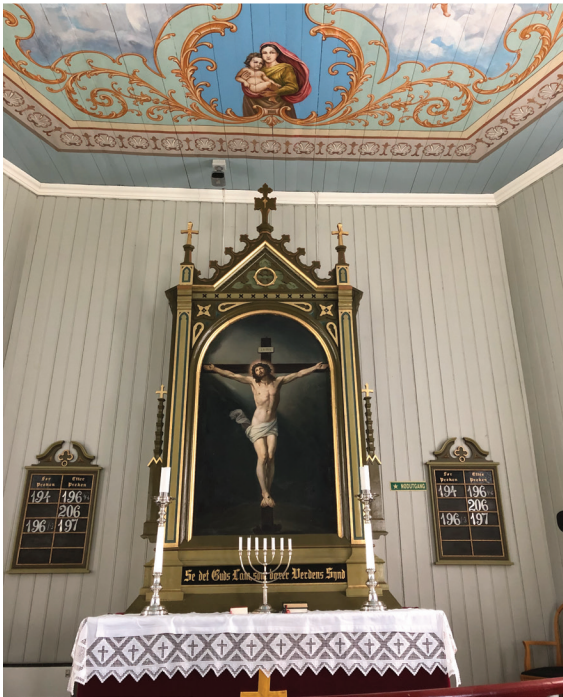
Figure 5. Mykland Church in Froland Municipality, with decorated ceilings (1931) by Torkild Gill. This is a typical example where documentation prior to a damage is crucial (as stated in Step 4). Photo: Nina Kjølsten Jernæs (2019).

Does the interior have decorated ceilings or walls? There might be challenges, such as the fire brigade needing to use the roof to let out smoke and rig for the fire hoses, damaging a painted ceiling (Figure 5). In general, the important parts or pieces cannot be covered or salvaged. To be prepared for the worst-case scenario, painted walls and ceilings should be documented with high-quality photographs, together with thorough descriptions of the materials, techniques and motifs. This will enable reconstruction or copying the decoration or the wallpaper after any damage (see Step 9). As Kincaid lists in his overview of the needs for a robust risk management plan, the records, drawings, photographs and other information on the whole building should be stored offsite for use in rebuilding in the event of partial or total damage (2012: 27).

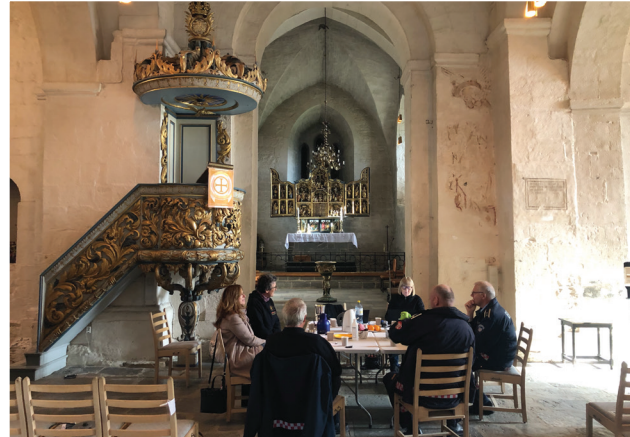
Figure 6. There is much to gain by discussing the interiors and possibilities for salvaging with local management, firefighters and conservators. This photo shows an emergency response meeting in Ringsaker medieval church, Ringsaker Municipality. Photo: Nina Kjølsen Jernæs (2020).
